HYDROGEOLOGIC AND GEOTECHNICAL ASSESSMENT OF APN 090-311-001 NIPOMO, CALIFORNIA

Prepared for:
NIPOMO COMMUNITY SERVICES DISTRICT

Prepared by:
FUGRO WEST, INC.

July 2008

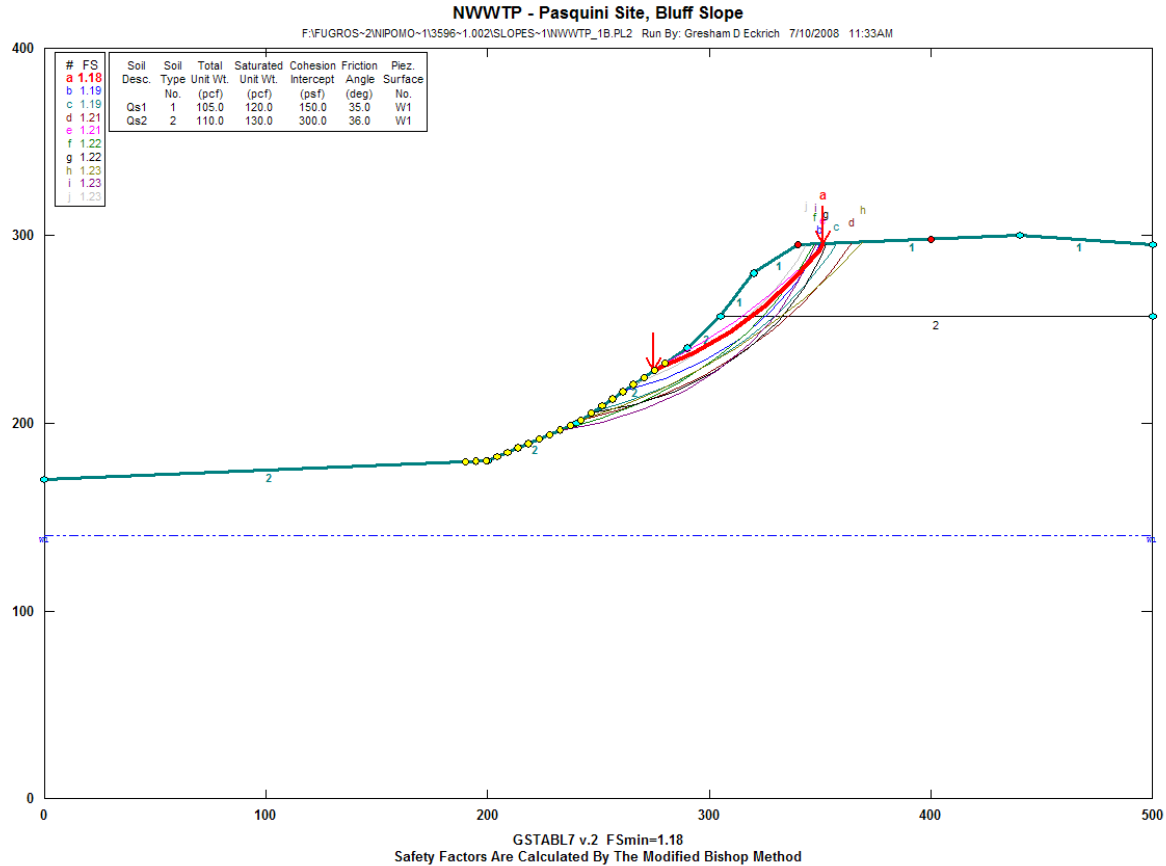
SLOPE STABILITY PLOT FOR BLUFF
Percolation Pond Feasibility Assessment
Nipomo, California

For the initial stability analysis of the bluff slope, strength parameters from direct shear tests were used to estimate factors of safety for slope stability. The estimated factor of safety from the initial analyses ranges from about 1.2 and 0.94 for static and pseudostatic conditions, respectively. The factors of safety are below the minimum 1.5 and 1.1 factors of safety used to define stable slope conditions for static and pseudostatic loading conditions. The existing bluff slope, at an inclination of about 1.2:1, is therefore considered potentially unstable relative to the minimum factors of safety used to define stable slope conditions. While evidence of deep-seated slope instability was not observed along the slope, the slope would still be considered potentially unstable or to have its stability compromised more easily than a slope that is considered stable. .

Static Loading Condition: 1.18
Pseudostatic Loading Condition: 0.94
Pseudostatic Coefficient: 0.15
Condition: Existing Slope

Note: Cohesion Value of Upper Unit
Based on Direct Shear Test Results

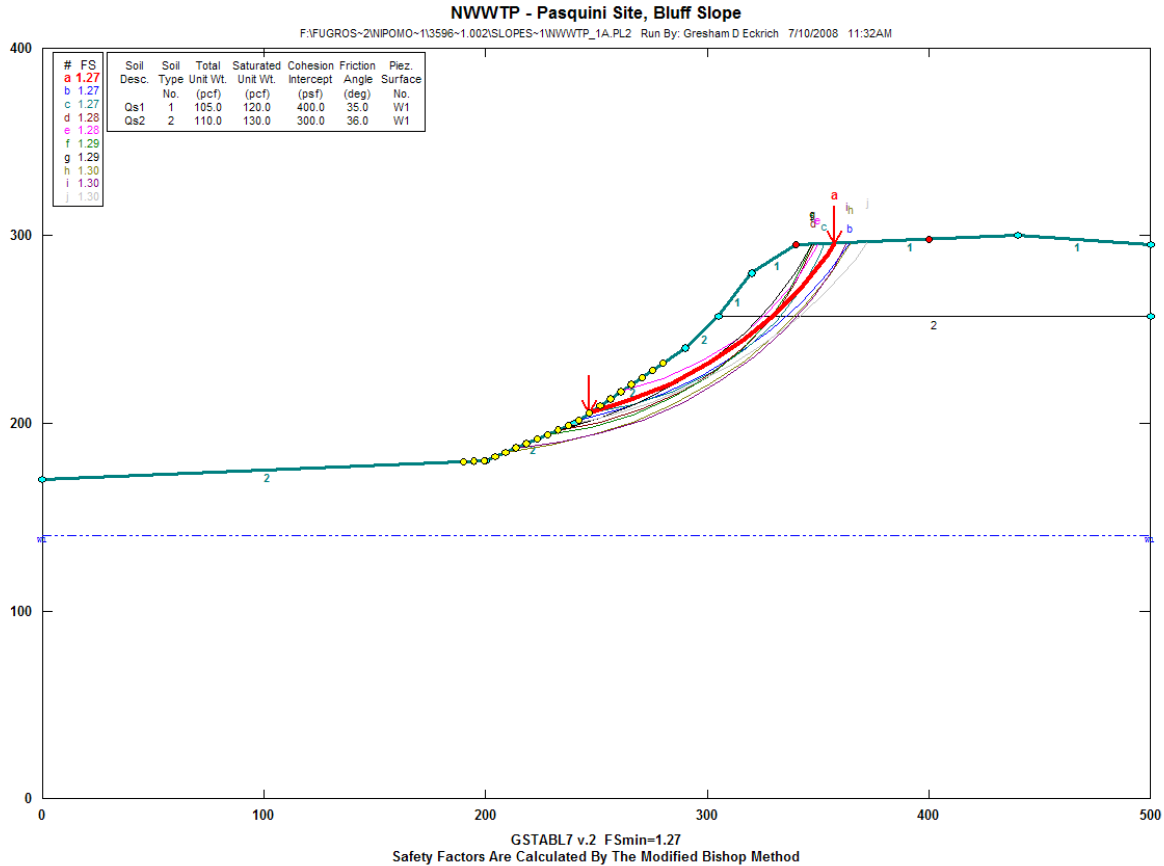
SLOPE STABILITY PLOT FOR BLUFF
Percolation Pond Feasibility Assessment
Nipomo, California

Further slope stability analysis of the bluff slope was performed to check the shear strength parameters used in the analysis compared to strength parameters estimated from the back-calculation analysis of the existing near-vertical slope within the drainage canyon. The cohesion estimated from the back calculation was about 400 psf, more than double that estimated from the direct shear tests. The estimated factors of safety for the existing bluff slope using the back-calculated cohesion is about 1.3 and 1.0 for static and pseudostatic conditions, respectively, suggesting that the stability of the slope may be better than initially estimated under static and pseudostatic loading conditions. The laboratory tests do suggest however, that the cohesive strength of the soil may be vulnerable to weakening when the soil is saturated.

Static Loading Condition: 1.27
Pseudostatic Loading Condition: 1.00
Pseudostatic Coefficient: 0.15
Condition: Existing Slope

Note: Cohesion Value of Upper Unit
Based on Back-Calculation
